**Naval Station Newport**

**Site 13 Time Critical Removal Action**

**Update: September 18, 2024**

# Technical Presentation: Site 13 - Tank Farm 5 Update

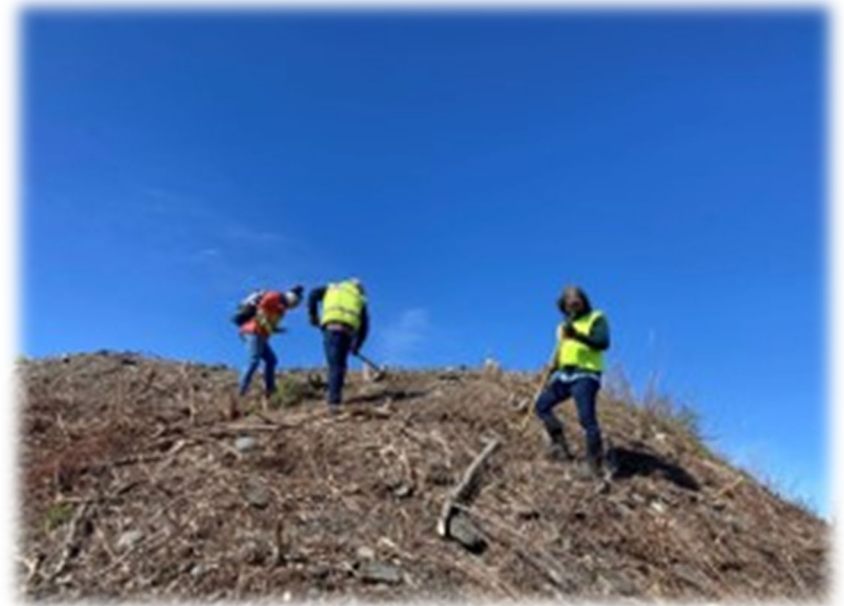
- Soil piles were recognized following the proposal to redevelop Tank Farm 5 as a solar generating facility.
- Stockpiles estimated at ~29,000 cubic yards.
- Mostly made up of soil, sand, gravel, and stone.
- Also contains concrete, brick, asphalt and pieces of building debris.
- Small amounts of suspected asbestos-containing building debris (floor tile, shingles).

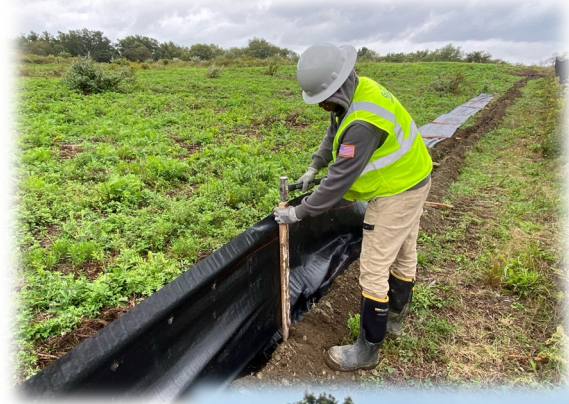
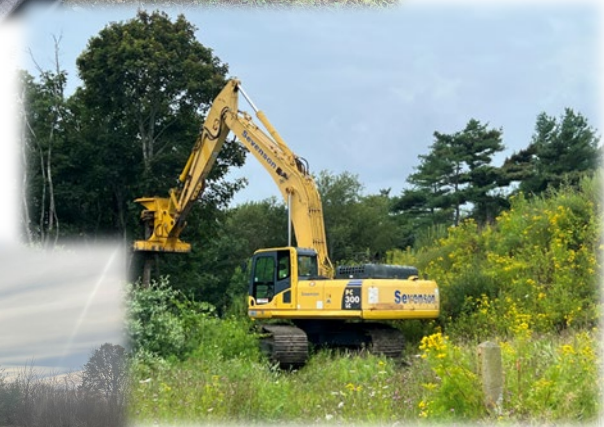
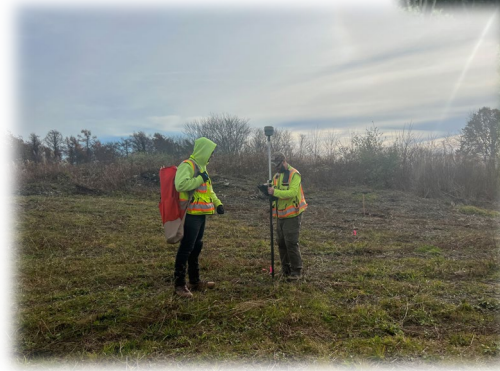
- ✓ Developed Removal Action Work Plan (RAWP), December 6, 2023
- ✓ Mobilized, cleared site, installed erosion controls, surveyed soil piles and completed site setup. Aug 10, 2023 - Feb 21, 2024
- ✓ Collected and Analyzed Samples from Soil Piles for Waste Characterization Purposes, Dec 4, 2023 – Jan 10, 2024
- ✓ Discovered four additional small piles and added them to the action plan (May 2024).
  - Plan to remove these piles in September

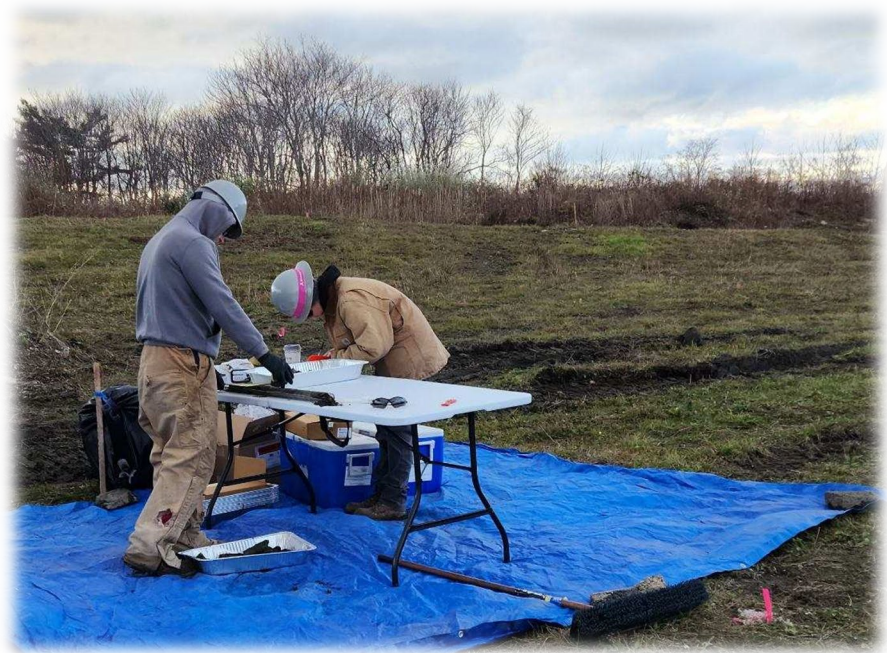
- All material was classified as asbestos containing waste.
- All material was non-TSCA (PCBs < 1 mg/kg)
- Most piles had detections of PFAS (Per- and Polyflouroalkyl substances) (non-detect to 5 ug/kg) – below the EPA RSLs.
- Arsenic concentrations in the soil piles ranged from 5.7 mg/kg to 53 mg/kg
- All but one sample were below the regulatory levels for TCLP analysis:
  - 2,4-DNT was found slightly above the regulatory level (0.22 mg/L vs. 0.13 mg/L).
  - 2,4-DNT has been used in explosives and other materials.
- No new contaminant sources found during excavation

Preparing composite waste characterization samples

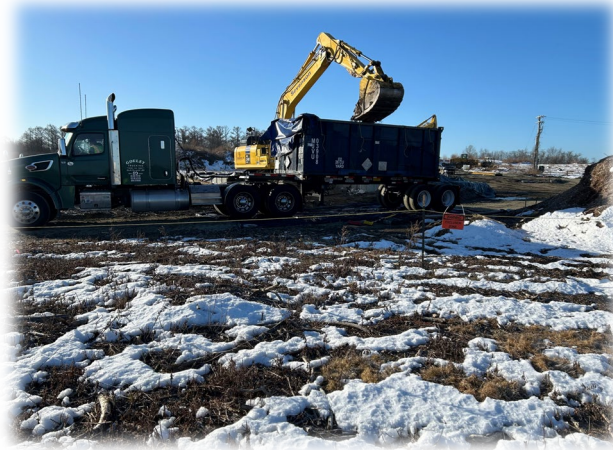
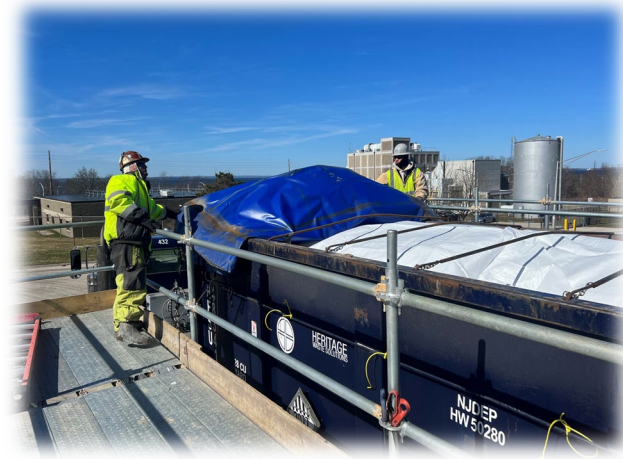
- Intermodal containers and dump trailers were lined before loading
- One excavator was used to dig material from the soil pile and a second excavator is used to load material into the lined intermodal containers or dump trailers
- GPS was used to guide the digging excavator to meet planned elevations

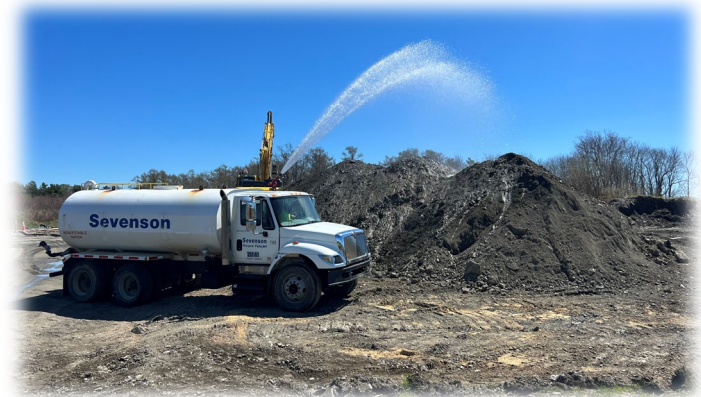
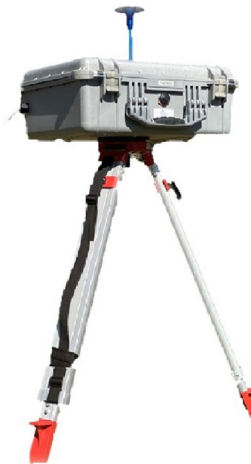
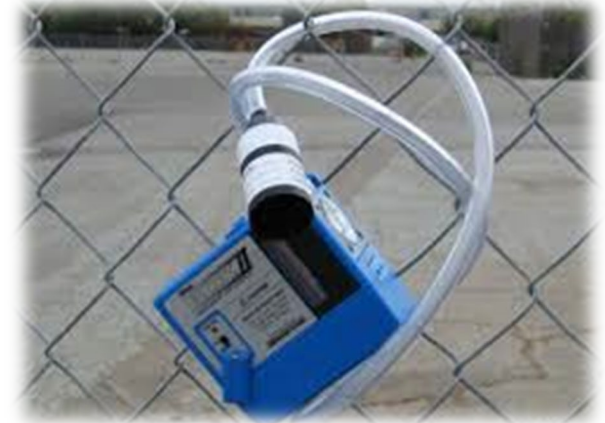
- During soil loadout and excavation activities, a water truck was used to keep soil moist and suppress dust.
- During soil loadout and excavation activities, downwind perimeter air monitoring was performed.
- One perimeter asbestos air sample hit the action level based on Phase Contrast Microscopy (PCM) analysis. Transmission Electron Microscopy (TEM) analysis of the sample indicated that the fibers detected were not asbestos fibers.
- No dust action levels were exceeded.

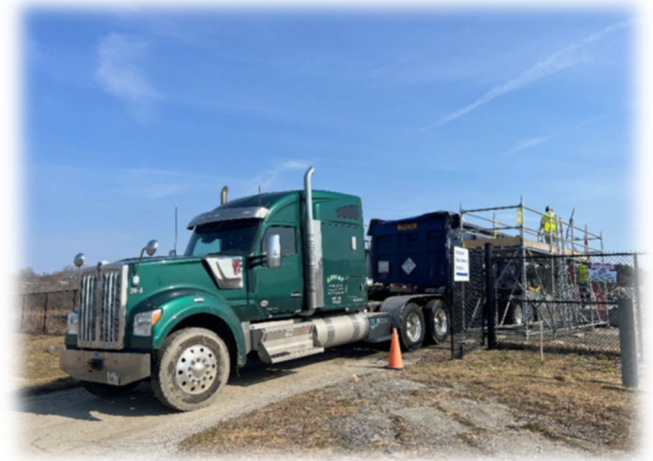
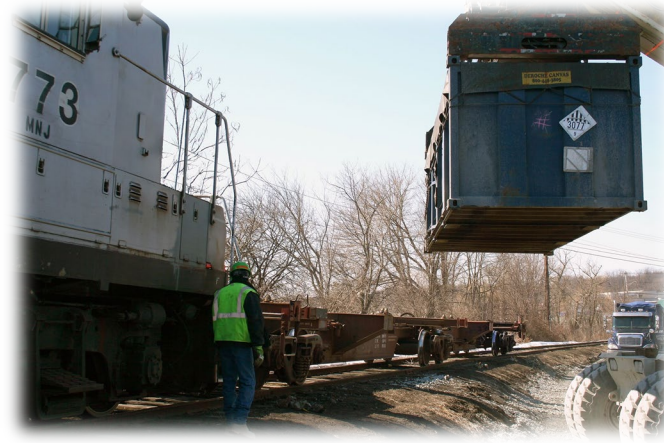
- After loading, trucks travelled to the truck decontamination area.
- After decontamination, liners in Intermodal containers and dump trailers were sealed, tarps were then placed over containers and dump trailers.
- Manifests were completed and checked prior to trucks leaving the site.
- Trucks were checked for required placards (UN3077, Environmentally Hazardous Substances).

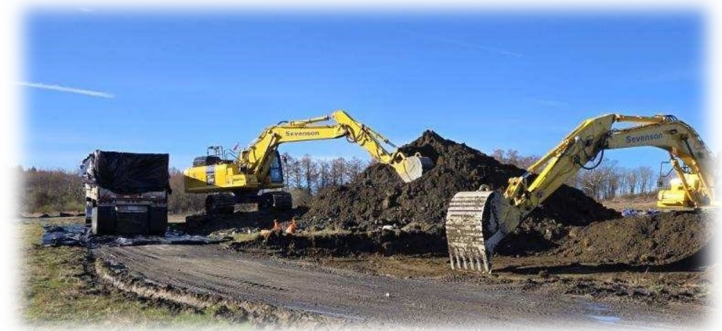
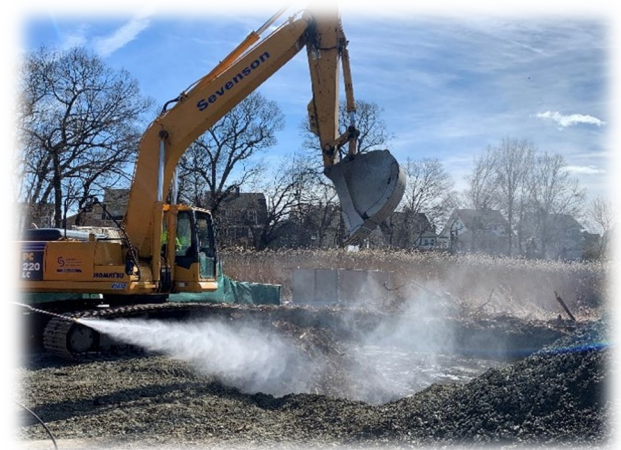
- ✓ Excavation, Transportation and Disposal of Soil Piles
  - ✓ 17,978 Tons of material sent to Heritage Environmental Services RCRA Subtitle C landfill in Roachdale, IN
  - ✓ 18,225 Tons of material sent to High Acres RCRA Subtitle D landfill in Fairport, NY
  - ✓ 14,455 Tons of material sent to Turnkey Subtitle D landfill in Rochester, NH
- ✓ Total to date = 50,658 tons (as of Friday 9/6)
- Approximately 100 tons still to be removed.
